Home Inspection

Prepared for: Sue Appreciative

123 Sample Rd
Small Town, NE 68000

Inspected by:
Jon Vacha
Home Standards Inspection Services

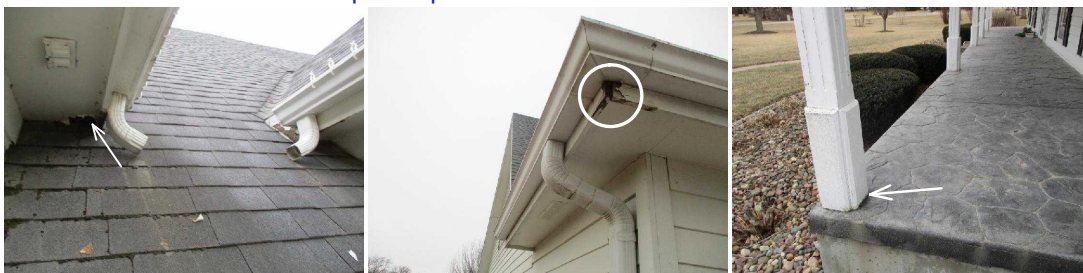
1. Soffit/Fascia/Trim: Composition board and Wood. Wood at a soffit area pictured deteriorated - this opening could allow birds or bats to enter the attic.

Wood worn at some fascia at areas indicating leaky gutter joints.

Wood at the base of some porch posts deteriorated.

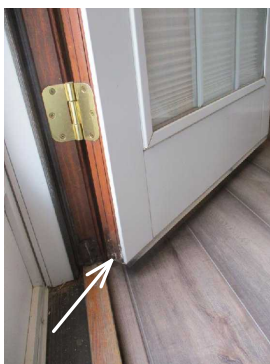
2. Patio Door: Wood at base of door to deck deteriorated.

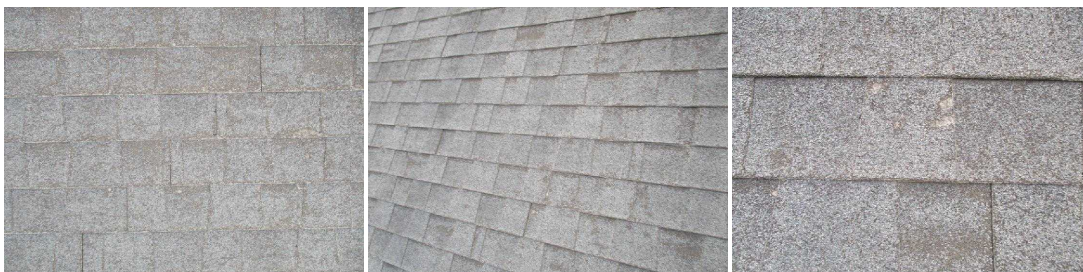
3. Roof Surface Material: Composition shingle. Pitting, bruising and granule loss noted at shingles indicating possible hits from hail - mostly at the south facing exposures. Recommend further evaluation as needed to determine if roof will be insured.

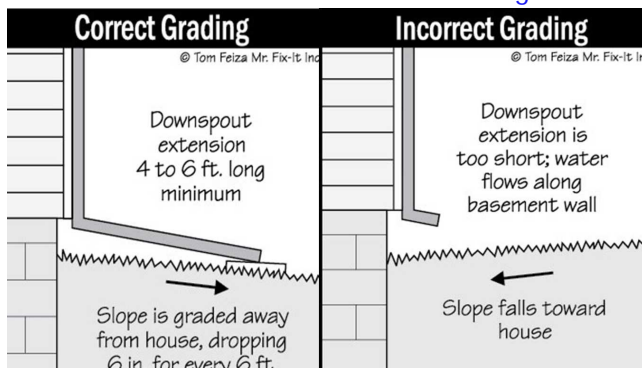
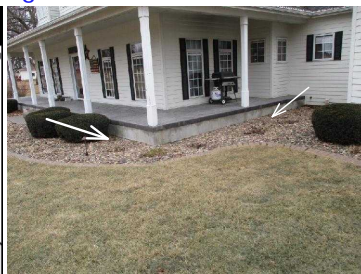
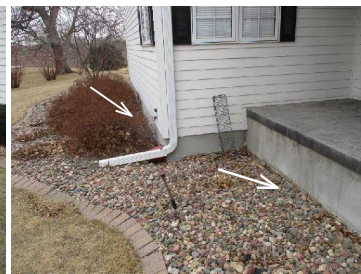
4. Grading: Earth has settled and slopes back along the foundation in places. A one inch per foot drop away from the foundation for 5 ft is recommended for good drainage.

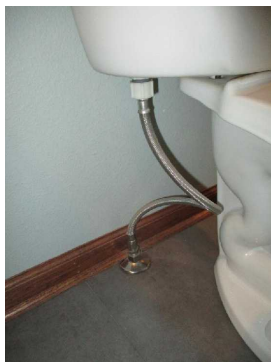
5. Master Bathroom Toilet: Shutoff valve not present.

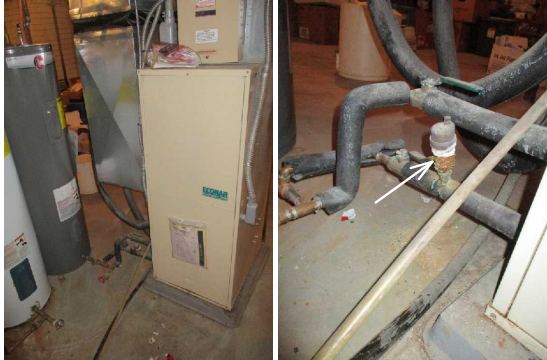
8. Heating System General Condition: No recent service tag present and due to the age recommend a service call and inspection by an HVAC tech who specializes in Geothermal heat pumps. Corrosion noted at a water line connection that runs to the water heater.

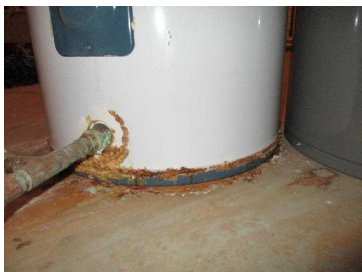
1. South Water Heater Water Heater Condition: **Base of water heater rusted, signs of leaking.**

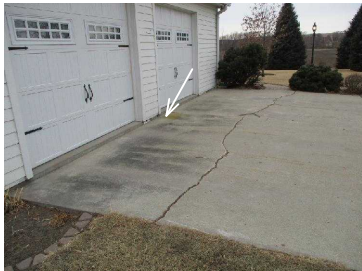
2. Driveway: Concrete. Driveway has cracked, settled near the garage floor creating a 1" or greater offset- possible trip concern.

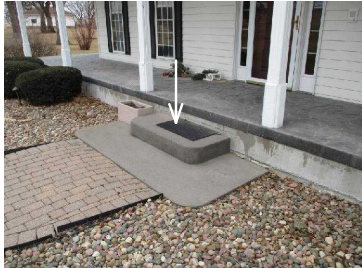
3. Walks/Steps: Concrete. Steps to stoop have settled, top step height is taller- this is a possible trip concern.

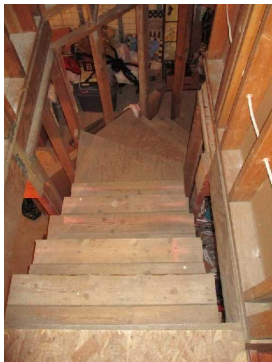
4. Living Space Stairs/Railings: Hand rail, guards not present at stairs to basement. Tread depth less, head room clearance less that what is suggested at stairs to basement.

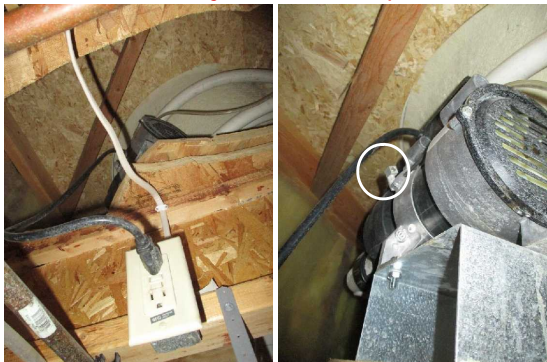
6. Master Bathroom Electrical: The jetted tub is plugged into a GFCI outlet that would not trip off when tested.

Ground wire for jet motor not present/visible.

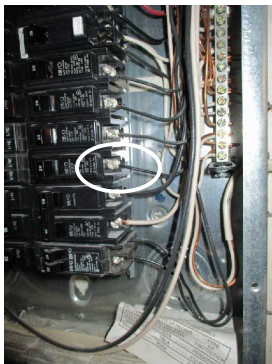
8. Basement Electric Panel Breakers/Fuses: Breakers - Sub-panel does not have separated ground and neutral bars. A breaker in the sub panel is oversized. For more info or adjustments consult an electrician.

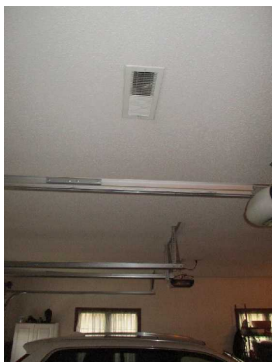
9. Heating System Venting System: There area vent openings in the garage. This is not recommended because CO from a car left running in the garage would enter the house through the duct work quickly.

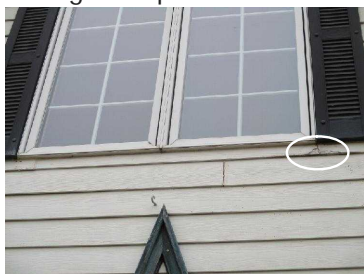
1. ☒ ☐ ☐ ☐ ☐ ☐ Siding: Composition Cement Board. Paint worn/peeling at isolated areas on exterior of house.

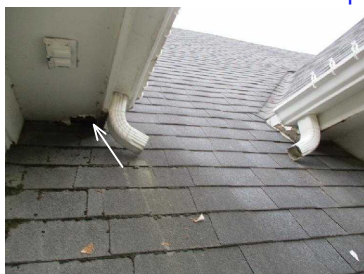
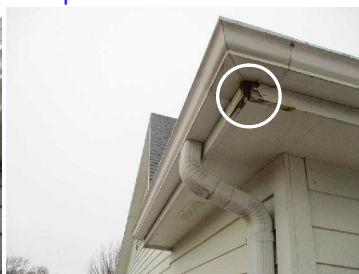
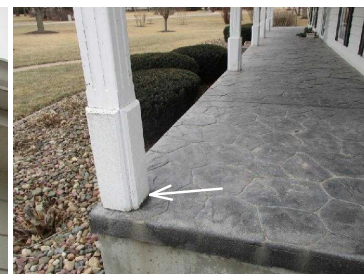
2. ☐ ☐ ☐ ☒ ☐ ☐ Soffit/Fascia/Trim: Composition board and Wood. Wood at a soffit area pictured deteriorated - this opening could allow birds or bats to enter the attic.

Wood worn at some fascia at areas indicating leaky gutter joints.

Wood at the base of some porch posts deteriorated.

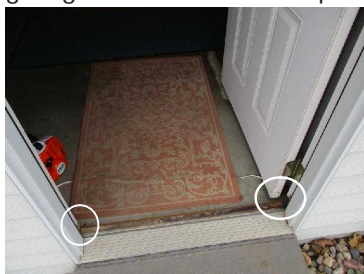
3. ☒ ☐ ☐ ☐ ☐ ☐ Door Bell: Present. Intercom systems are not inspected.
4. ☒ ☐ ☐ ☐ ☐ ☐ Entry Doors: Suggest sealing (painting) the base of the door jamb and door at the door from the garage to the exterior to prevent future wood rot.

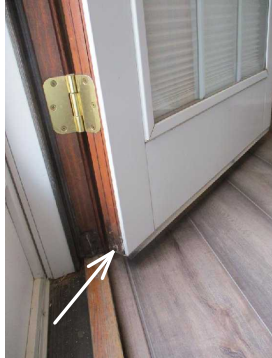
5. ☐☐☐☒☐☐ Patio Door: Wood at base of door to deck deteriorated.

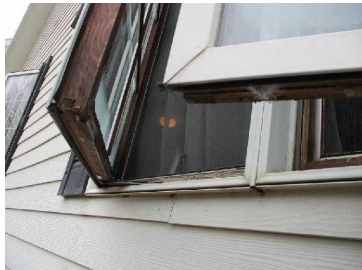
6. ☒☐☐☐☐☐ Window Frames/Sills: Suggest resealing (staining) the wood sash at garage windows to protect from future wood rot.

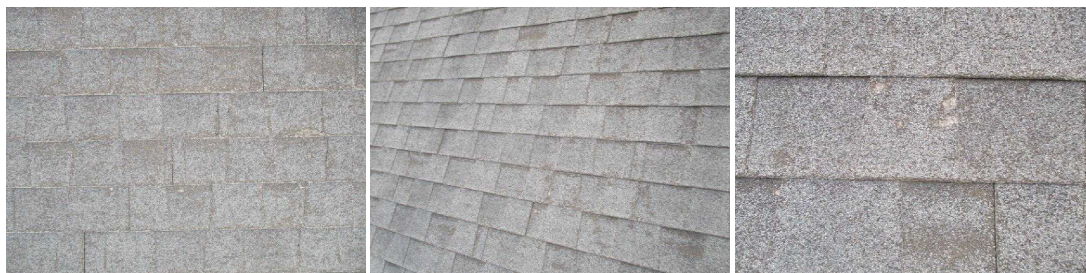
3. ☐ ☐ ☐ ☒ ☐ ☐ Material: Composition shingle. Pitting, bruising and granule loss noted at shingles indicating possible hits from hail - mostly at the south facing exposures. Recommend further evaluation as needed to determine if roof will be insured.

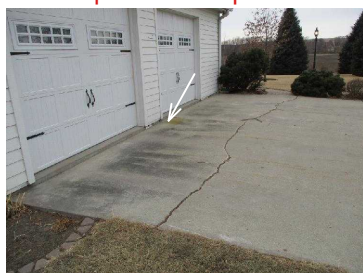
1. ☐ ☐ ☐ ☐ ☐ ☒ Driveway: Concrete. Driveway has cracked, settled near the garage floor creating a 1" or greater offset- possible trip concern.

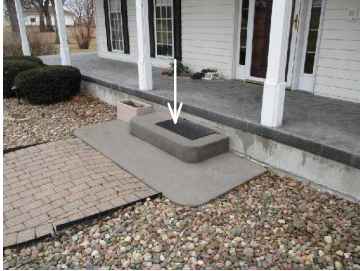
2. ☐☐☐☐☐☒ Walks/Steps: Concrete. Steps to stoop have settled, top step height is taller- this is a possible trip concern.

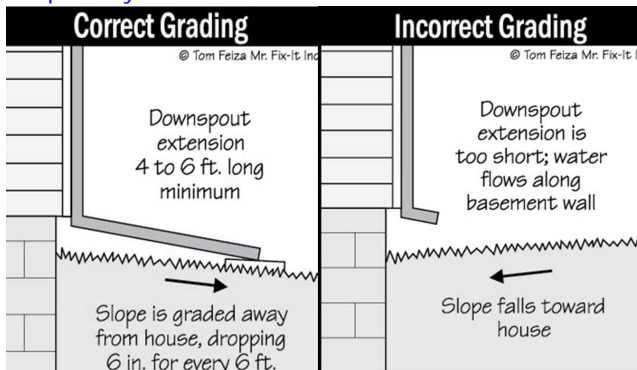
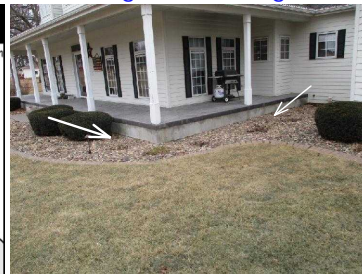
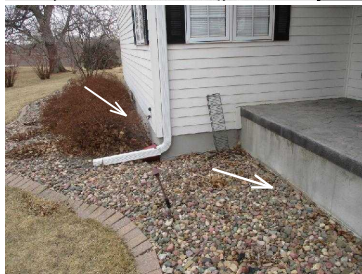
3. ☒☐☐☐☐☐ Porch/Stoop: Concrete.
4. ☒☐☐☐☐☐ Wood Deck: Composition Decking
5. ☐☐☐☒☐☐ Grading: Earth has settled and slopes back along the foundation in places. A one inch per foot drop away from the foundation for 5 ft is recommended for good drainage.

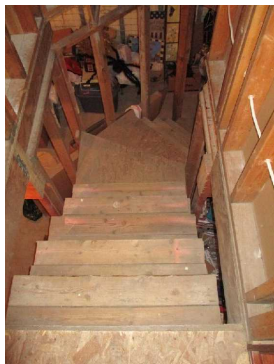
1. ☒ ☐ ☐ ☐ ☐ ☐ Walls/Ceilings:
2. ☒ ☐ ☐ ☐ ☐ ☐ Floors:
3. ☒ ☐ ☐ ☐ ☐ ☐ Doors:
4. ☒ ☐ ☐ ☐ ☐ ☐ Windows: Some screens worn or damaged. Note that some windows have built in blinds and some do not.
5. ☒ ☐ ☐ ☐ ☐ ☐ Electrical: 110 VAC
6. ☐ ☐ ☐ ☐ ☐ ☒ Stairs/Railings: Hand rail, guards not present at stairs to basement. Tread depth less, head room clearance less that what is suggested at stairs to basement.

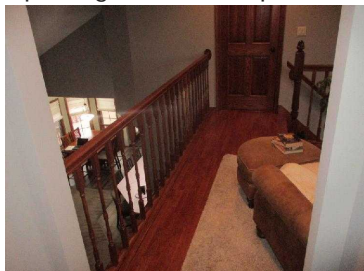
7. ☒ ☐ ☐ ☐ ☐ ☐ Stairs/Railings: A post would be present half way at the longer upper guard per typical practices. Openings between spindles is wider than 4".

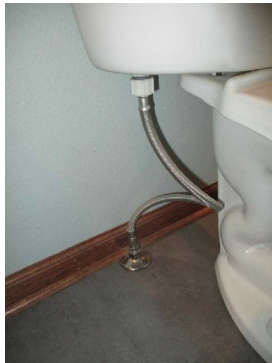
1. ☐☐☐☒☐☐ Toilet: Shutoff valve not present.

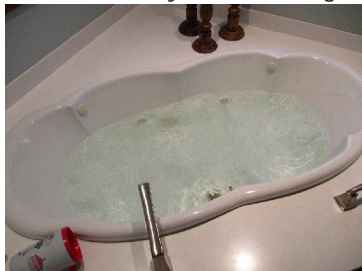
3. ☒☐☐☐☐☐ Tub/Surround: Note: Jetted tub was filled above water jets and operated to check intake and jets. Jets are ready for cleaning.

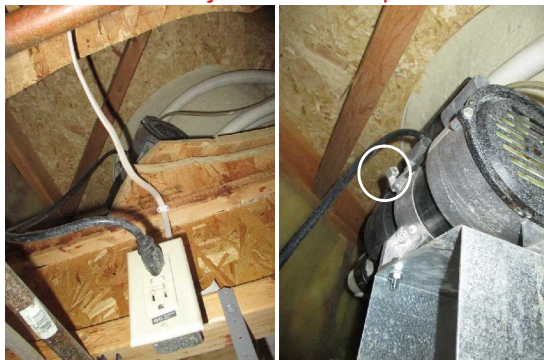
6. ☐☐☐☐☐☒ Electrical: The jetted tub is plugged into a GFCI outlet that would not trip off when tested.

Ground wire for jet motor not present/visible.

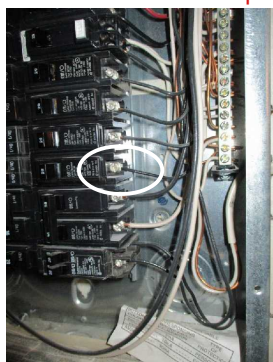
8. ☐ ☐ ☐ ☐ ☐ ☒ Breakers/Fuses: Breakers - Sub-panel does not have separated ground and neutral bars. A breaker in the sub panel is oversized. For more info or adjustments consult an electrician.

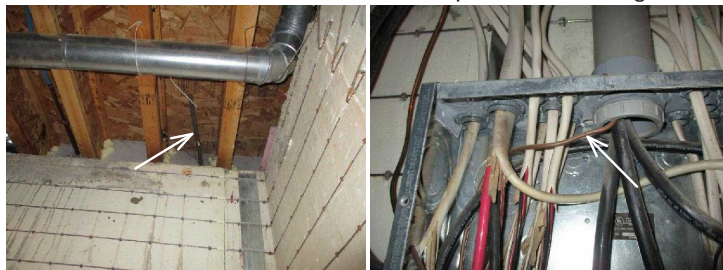
9. ☒ ☐ ☐ ☐ ☐ ☐ Ground: Note that there is a rebar located at a rim joist area in the crawl space - running a ground wire from this to the panel may provide solid ground for the house electrical system. Ground wire runs into conduit from panel - house ground not visibly attached to anything else.

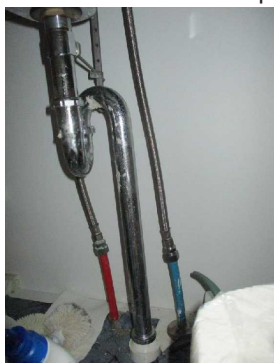
3. ☒ ☐ ☐ ☐ ☐ ☐ Water Lines: Copper, Plastic (Pex)
4. ☒ ☐ ☐ ☐ ☐ ☐ Drain/Vent Pipes: PVC. S-traps present under some sinks. S-traps are typically not preferred - for more info consult a plumber.

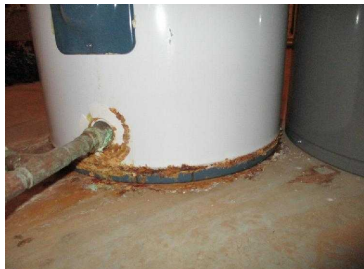
11. ☐ ☐ ☐ ☐ ☒ ☐ Water Heater Condition: Base of water heater rusted, signs of leaking.

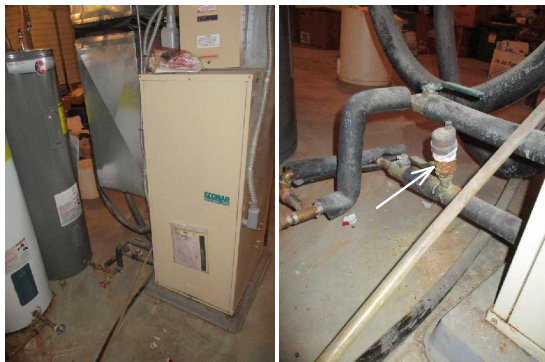
1. ☒ ☐ ☐ ☐ ☐ Heating System Operation: Unit operating in heating mode at time of inspection.
2. ☐ ☐ ☐ ☒ ☐ General Condition: **No recent service tag present and due to the age recommend a service call and inspection by an HVAC tech who specializes in Geothermal heat pumps. Corrosion noted at a water line connection that runs to the water heater.**

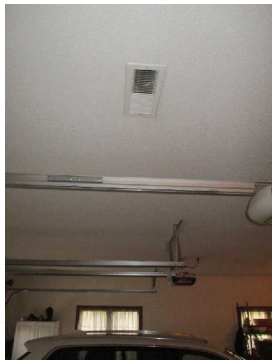
8. ☐☐☐☐☐☒ Venting System: There area vent openings in the garage. This is not recommended because CO from a car left running in the garage would enter the house through the duct work quickly.
