Home Inspection

Prepared for: Sue Appreciative

123 Sample Rd
Small Town, NE 68000

Inspected by:
Jon Vacha
Home Standards Inspection Services

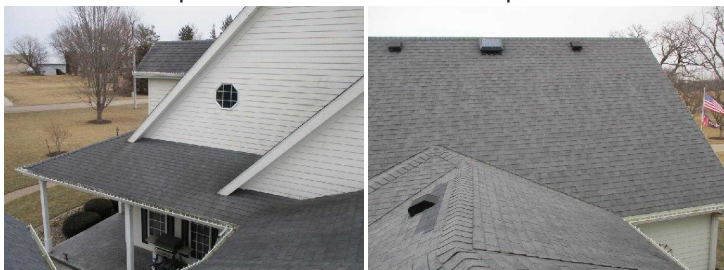
3. ☐ ☐ ☐ ☒ ☐ ☐ Material: Composition shingle. Pitting, bruising and granule loss noted at shingles indicating possible hits from hail - mostly at the south facing exposures. Recommend further evaluation as needed to determine if roof will be insured.

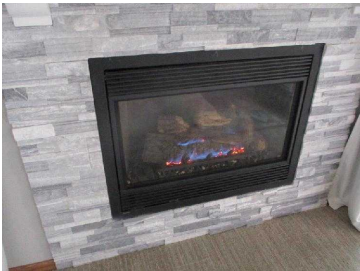
2. ☐☐☐☒☐☐ Firebox: Metal. Air circulating fan was not operating at time of inspection - fireplace was running at start and had heated up. Suggest asking seller about fan.

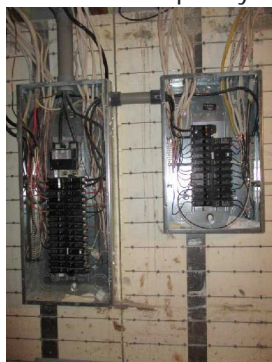
Basement Electric Panel

8. ☐ ☐ ☐ ☐ ☐ ☒ Breakers/Fuses: Breakers - Sub-panel does not have separated ground and neutral bars. A breaker in the sub panel is oversized. For more info or adjustments consult an electrician.

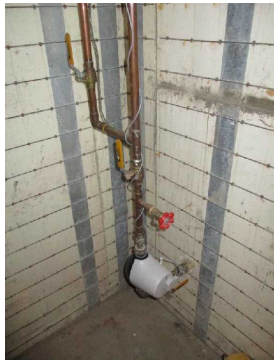
3. ☒ ☐ ☐ ☐ ☐ ☐ Water Lines: Copper, Plastic (Pex)
4. ☒ ☐ ☐ ☐ ☐ ☐ Drain/Vent Pipes: PVC. S-traps present under some sinks. S-traps are typically not preferred - for more info consult a plumber.

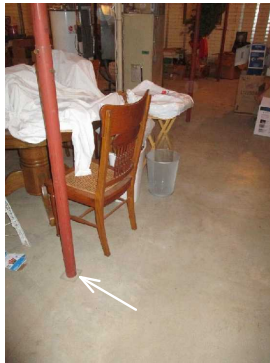
1. ☒ ☐ ☐ ☐ ☐ ☐ Construction Type: Masonry.
2. ☒ ☐ ☐ ☐ ☐ ☐ Foundation Walls: Poured concrete, styrofoam.
3. ☒ ☐ ☐ ☐ ☐ ☐ Support Beams: Wood Beam.
4. ☒ ☐ ☐ ☐ ☐ ☐ Support Columns: Steel Posts - Note that posts are resting on the basement floor. Inspector cannot verify that footings are located under the slab at these areas.
